Rice Drilling D, LLC

NSPS Subpart OOOOa Annual Report

Rice Drilling D, LLC NSPS Subpart OOOOa Annual Report

Big Dawg 1HA, 3HA, 5H, 7H Leaking Components Report

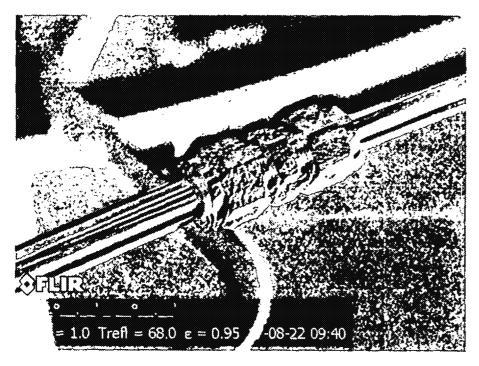
DRAW-20170822-008IR Repaired

Location: 3H GPU Run 2 Pilot Gas
Date & Time: 8/22/2017 9:55:00 AM
Geolocation: N 39° 57' 4.76", W 81° 5' 49.20"

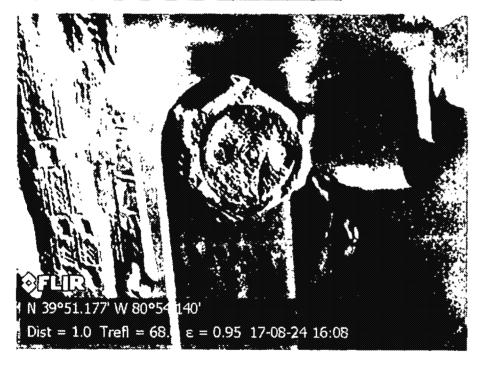
JUNK-20170824-001IR Repaired

Location: 2H Well Head Grease Fitting

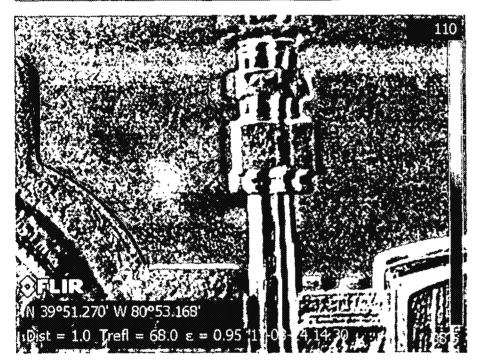
MONS-20170824-002IR Repaired

Location: 5H GPU Run 1 Burner Stainless Fitting

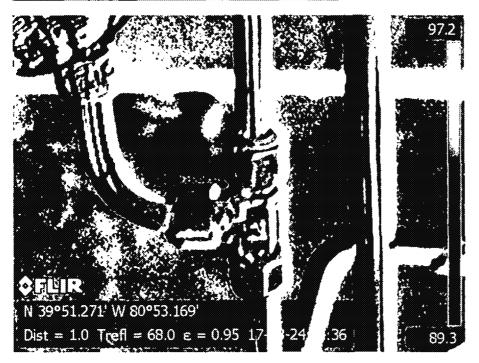
MONS-20170824-004IR Repaired

Location: 5H GPU Run 2 Stainless Fitting

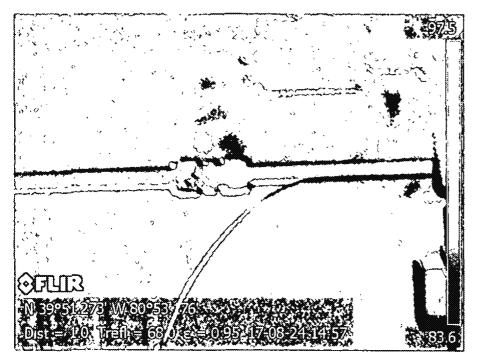
MONS-20170824-006IR Repaired

Location: 1H GPU Run 1 High- Low Supply Line

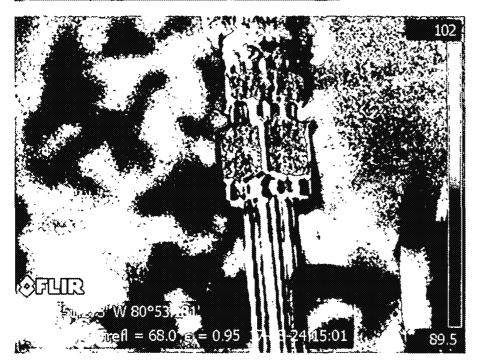
MONS-20170824-008IR Repaired

Location: 1H GPU High- Low Box Stainless Fitting

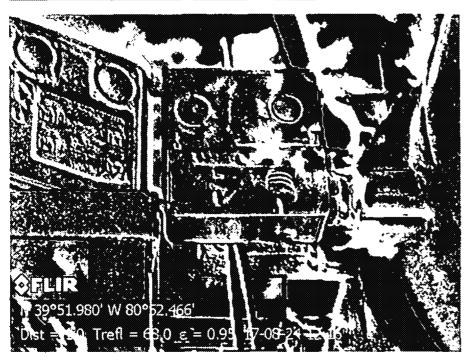
SPIT-20170824-001IR Repaired

Location: Dehy Liquid level Controller Date & Time: 8/24/2017 12:23:14 PM

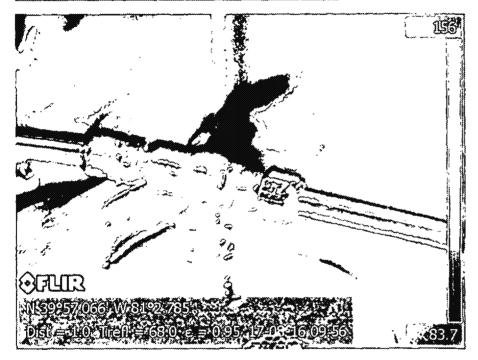
TACO-20160816-008IR Repaired

Location: 5H GPU Run 2 High Low Quick Exhaust

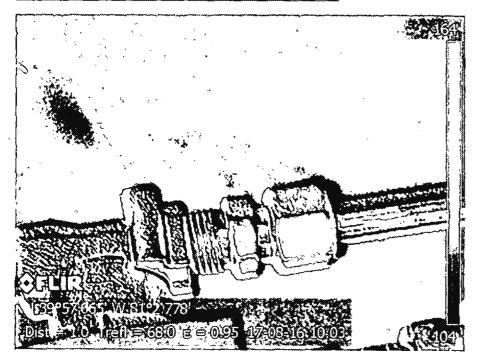
TACO-20160816-010IR Repaired

Location: 5H GPU Run 2 Fuel Gas Stainless Fitting

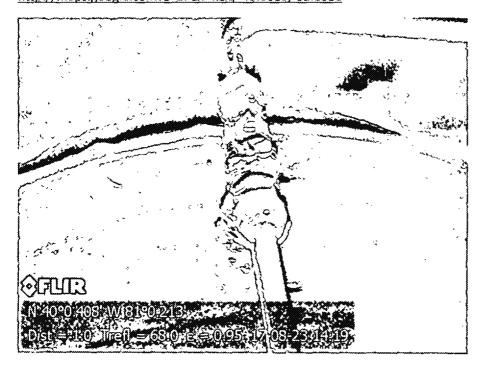
THRA-20170823-002IR Repaired

Location: 1H GPU Run 2 High- Low Quick Exhaust

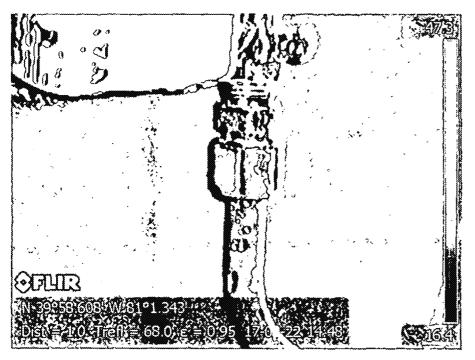
THUN-20170822-002IR Repaired

Location: 4H GPU Run 1 Pilot Date & Time: 8/22/2017 4:15:20 PM

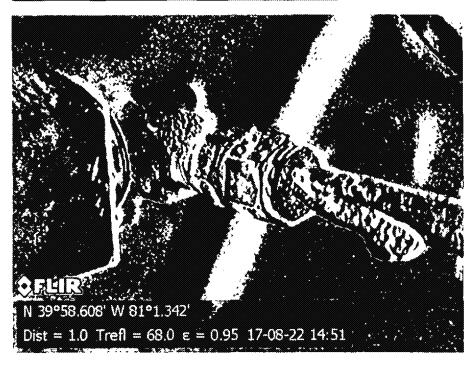
THUN-20170822-003IR Repaired

Location: 4H GPU Run 2 Solenoid Stainless Fitting

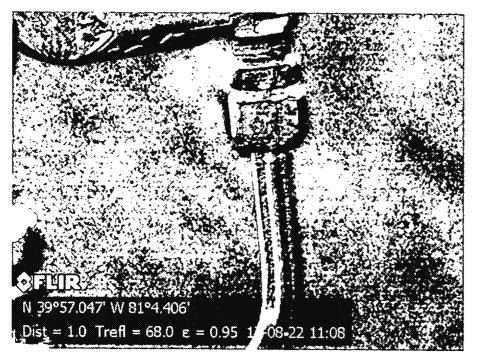
### TUNA-20170822-003IR Repaired

Location: 7H GPU Run 1 Pilot Gas Stainless Fitting

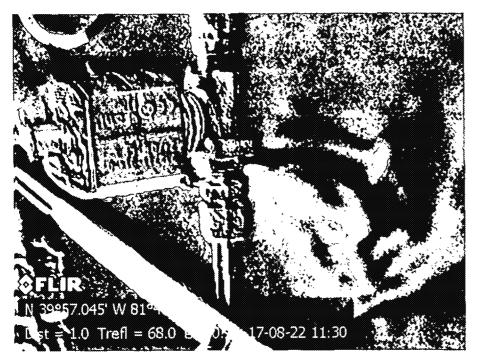
### TUNA-20170822-005IR Repaired

Location: 5H GPU Run 2 Solenoid Stainless Fitting

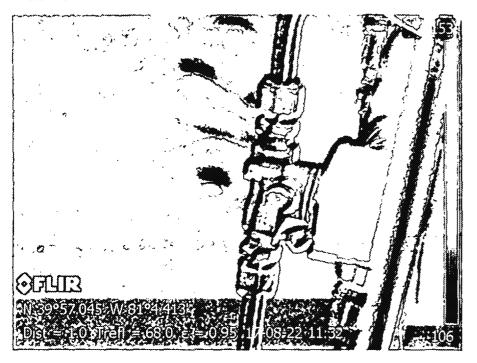
### TUNA-20170822-006IR Repaired

Location: 5H GPU Run 1 Solenoid Stainless Fitting

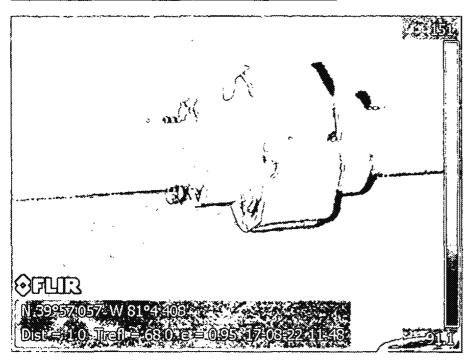
### TUNA-20170822-007IR Repaired

Location: 3H GPU Run 2 Fuel Supply Union

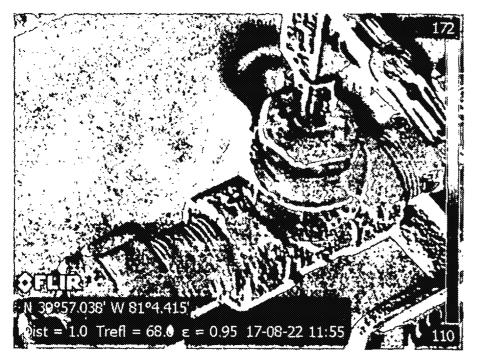
### TUNA-20170822-010IR Repaired

Location: 3H GPU Run 1 Fuel Supply Gauge

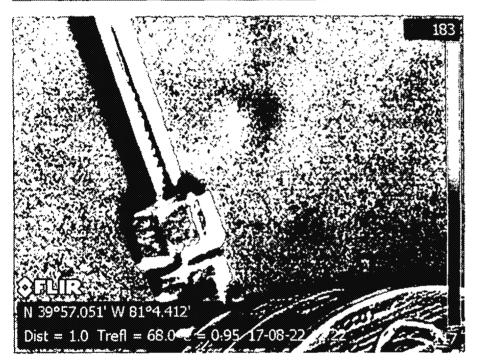
#### TUNA-20170822-011IR Repaired

Location: 1H GPU Run 2 Pilot Gas Stainless Fitting

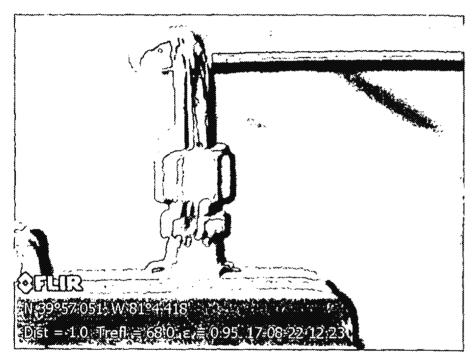
### TUNA-20170822-012IR Repaired

Location: 1H GPU Run 2 Union
Date & Time: 8/22/2017 12:39:34 PM
Geolocation: N 39° 57' 2.42", W 81° 4' 24.93"
